California Fish Passage Advisory Committee Connectivity Case Studies

June 17, 2020 www.cafishpac.org

Cedar Creek

Quiota Creek Restoration and Refugia Road

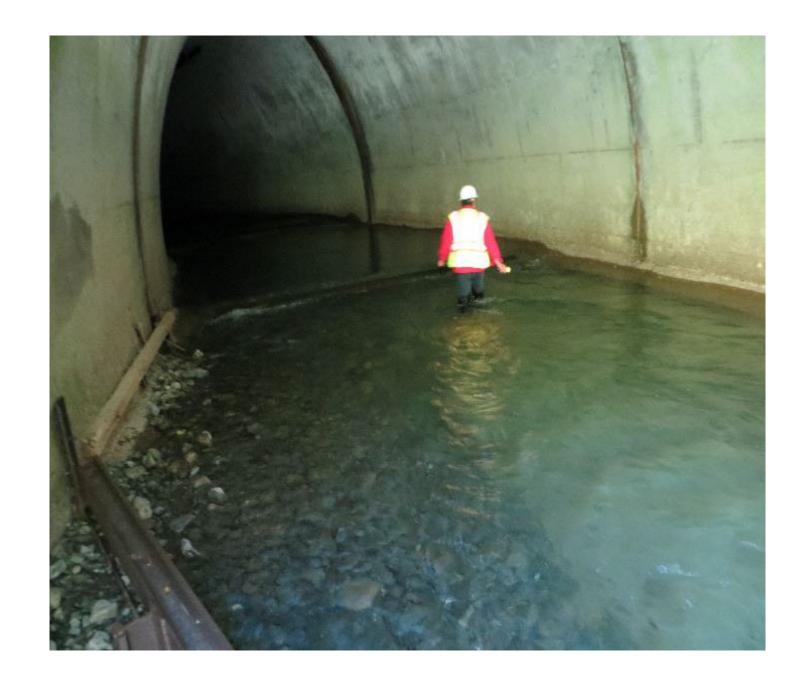
Existing Facility

- Constructed 1969
- 22' Concrete Arch Culvert
- 763' long
- 1.2% slope
- 24 steel armored concrete weirs
- Concreted RSP apron
- Denil Fish Ladder

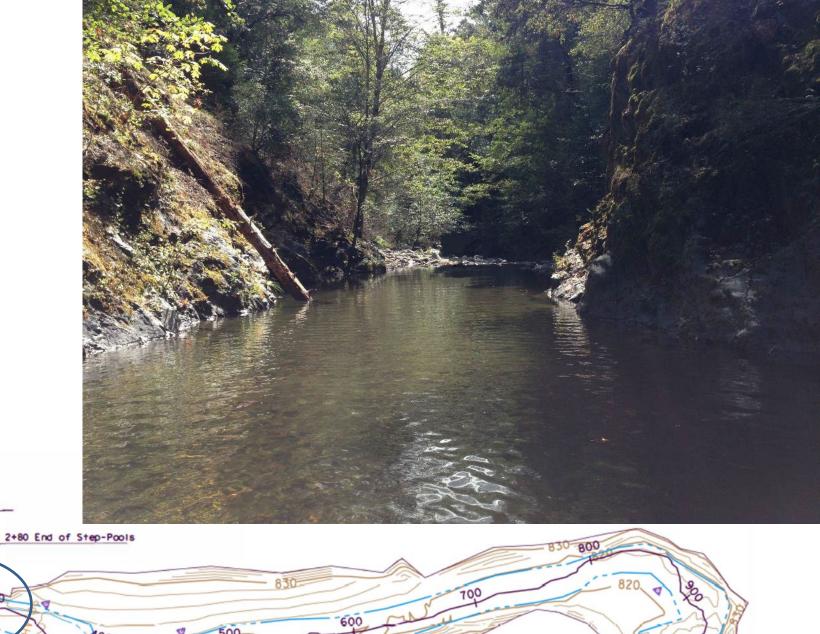
The Narrow

Outlet Begin Ain. 0+00

1+20 End of Weirs

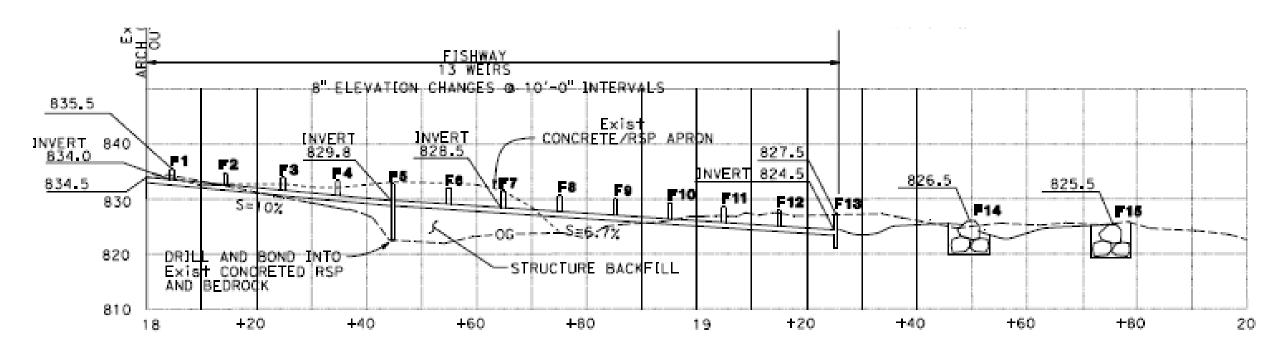
Downstream Channel Weirs -Stage 1

PROFILE

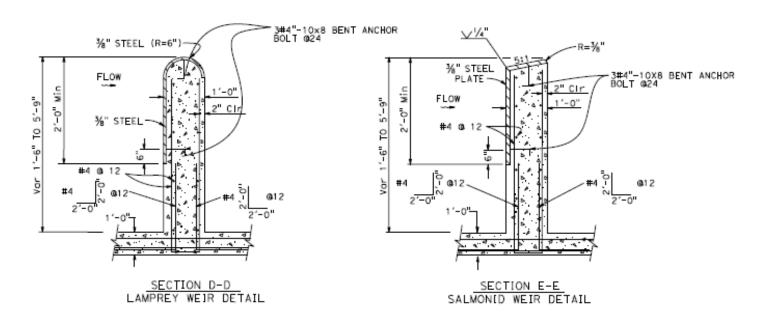
FISHWAY CONCRETE WEIRS
TYPICAL SECTIONS

Typical Lamprey and Salmonid Weirs

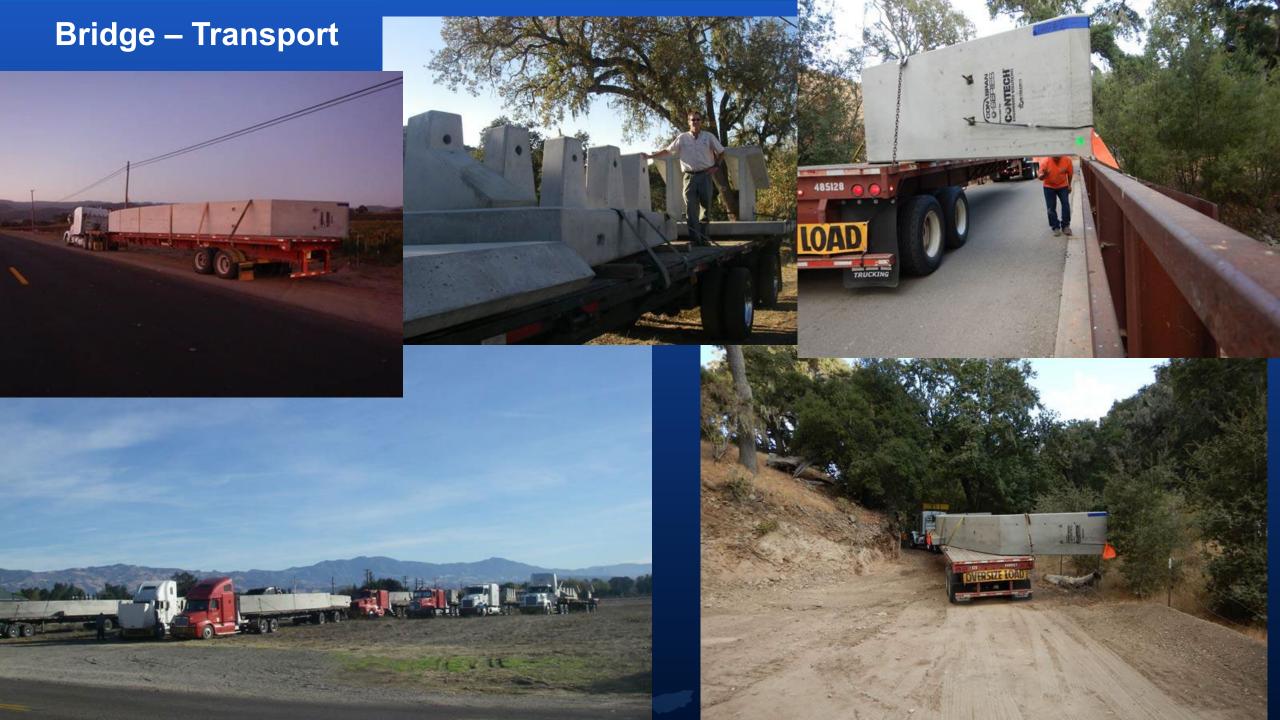
Concrete Curing Temperature Monitoring (Section 90-4.01D(2)(d)

- 1. Maximum internal concrete temperature can't exceed 165 degrees F
- 2. Internal temperature gain can't exceed 40 degrees F per hour

- Measured max temperature: 105 115 degrees F
- Smooth curing temperature cures

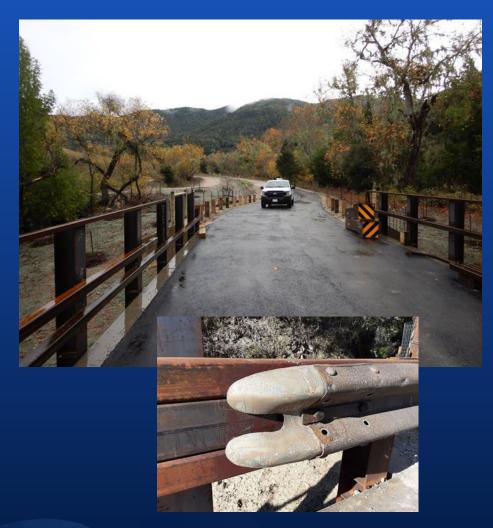
Guardrails and Bridge-Rails

- Standard galvanized Midwest Guardrail System with Caltrans approved inline 31" terminal system and Natina coating
- Modified FHWA California Type 115 bridge rail with single bike rail at 54-inches utilizing corten weathering steel

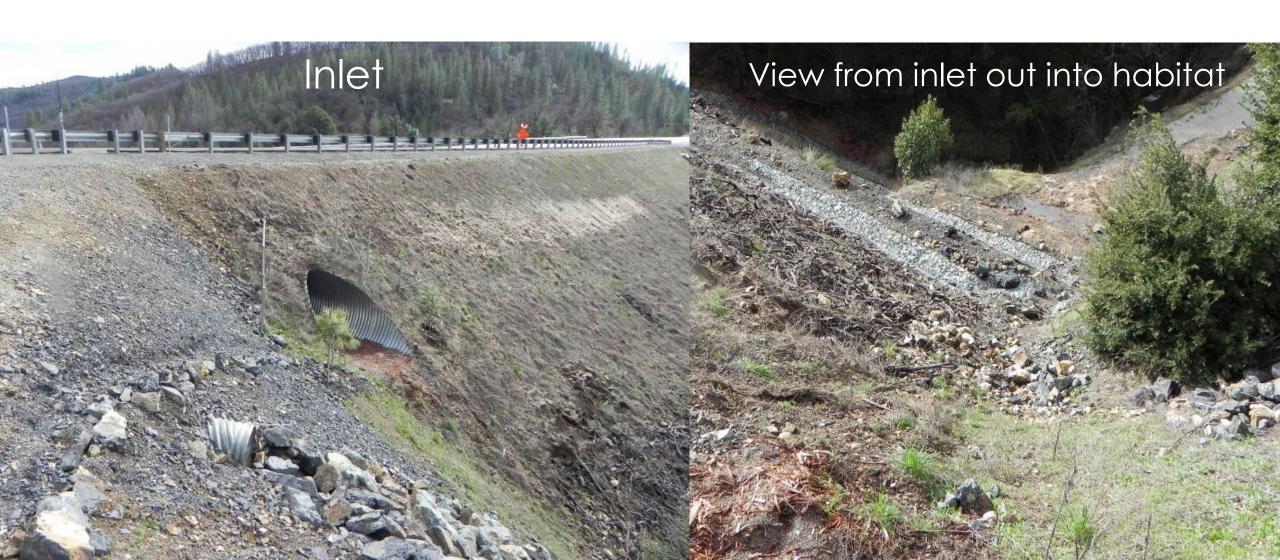
Water Gulch (96" x 155")

Water Gulch

Outlet

View from outlet into habitat

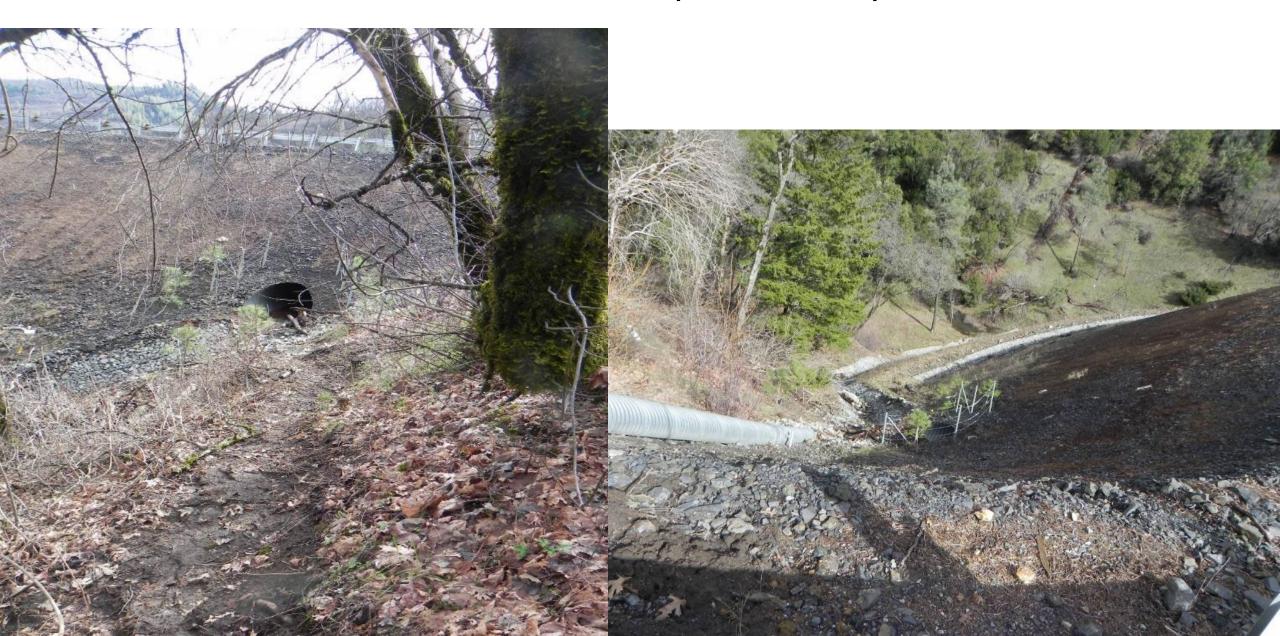
Trail Gulch (72"x 204")

- Planting
- Mulch

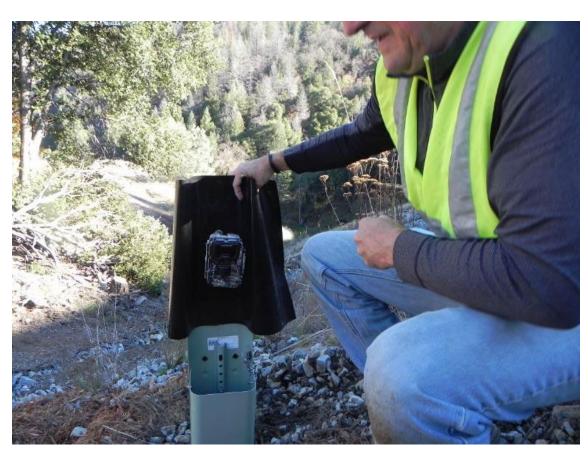
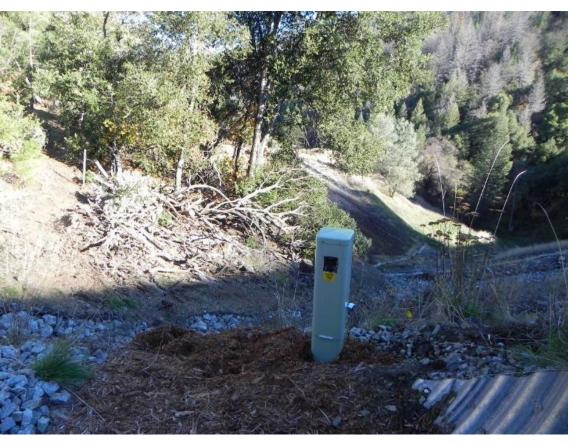
Cameras placed at every entrance
